VALLEY VIEW LAKE DAM

NDI ID No. PA-01006  
DER ID No. 19-75

PHASE I INSPECTION REPORT

11 FEBRUARY 1981

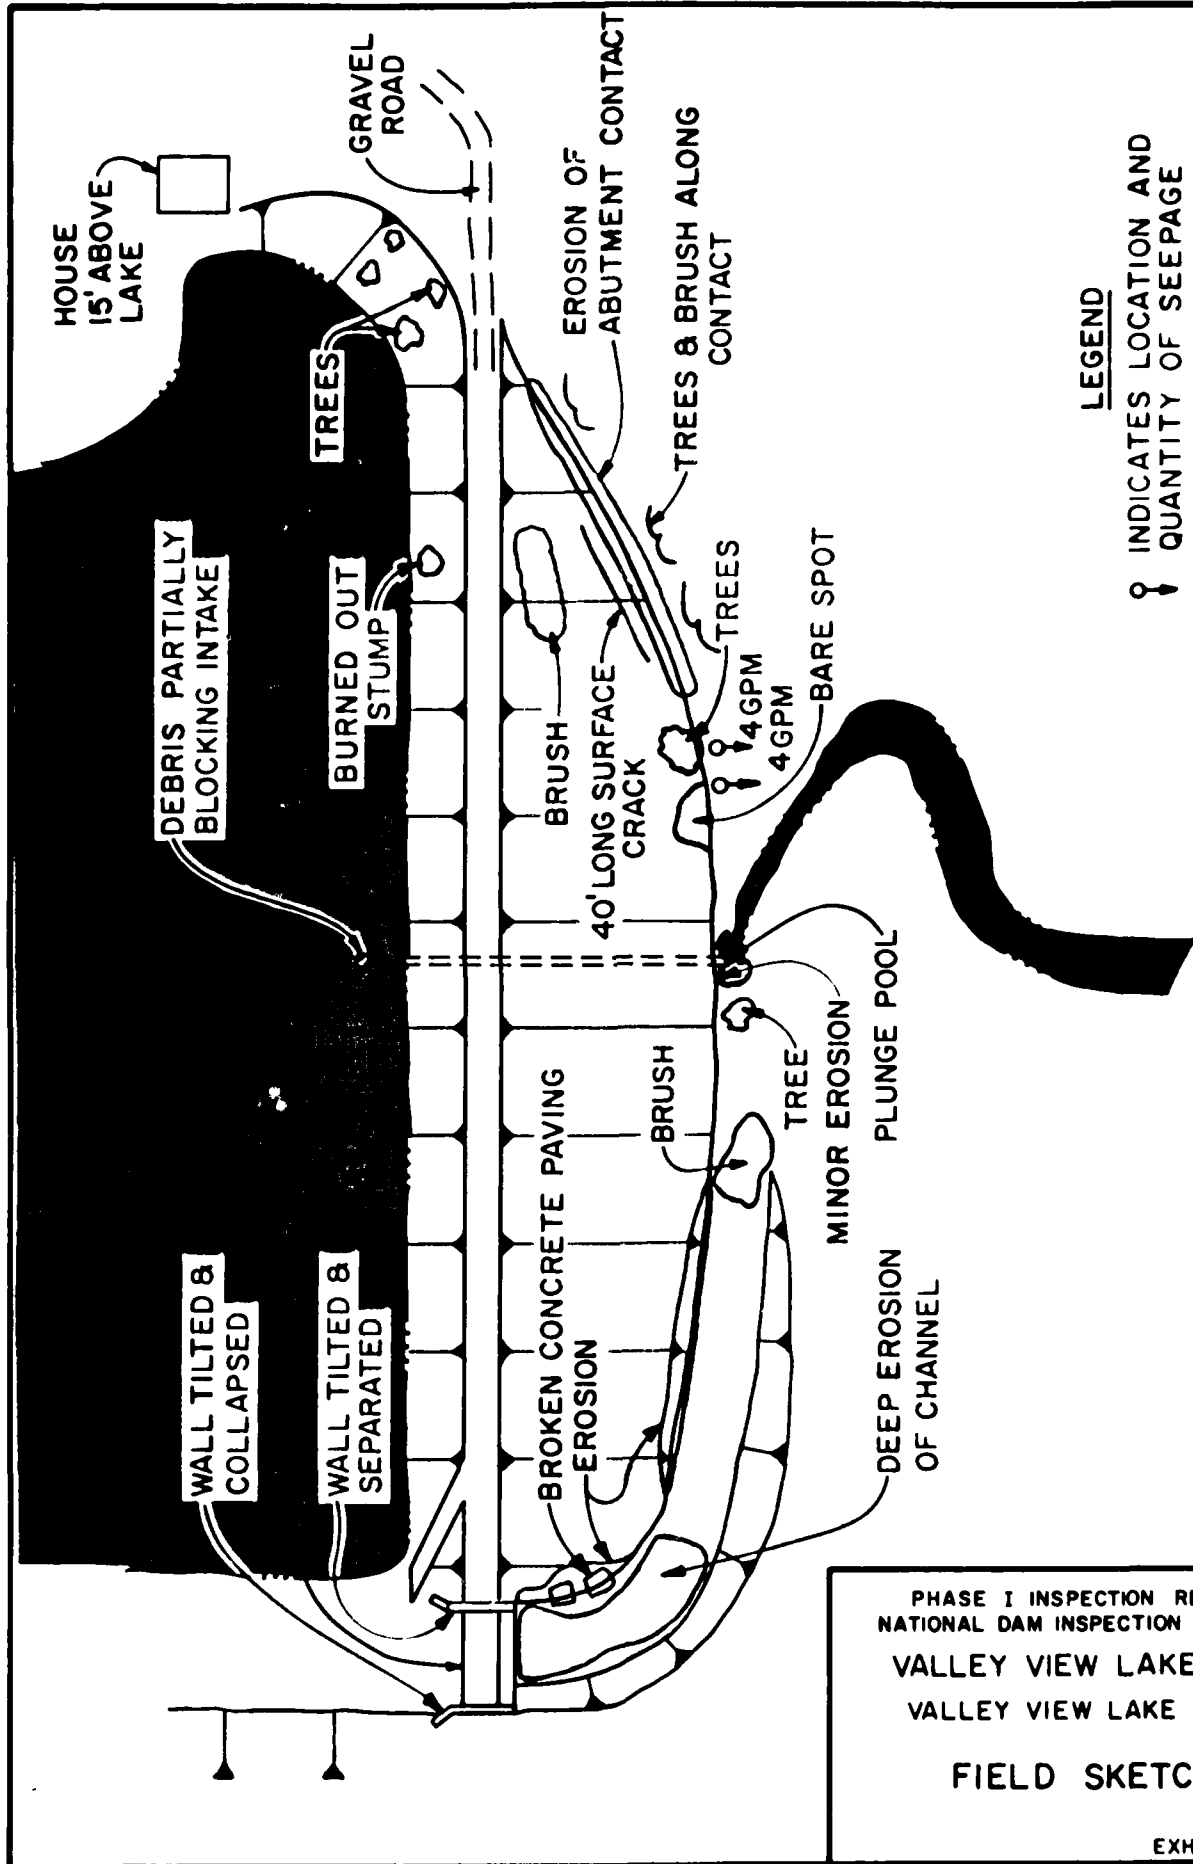
EXHIBIT A-1

5.3 Visual Observations. On the date of the inspection, conditions were present that may prevent the facility from operating as designed during a flood event. The spillway walls have deteriorated and are now leaning into the spillway opening. Immediately, downstream of the spillway slab, erosion has scoured out portions of the downstream channel adjacent to the embankment. This area had been filled with leaves and brush. Although this material presents no obstruction to flow, it did prevent a thorough inspection of the outlet channel. See Exhibit A-1 of Appendix A.

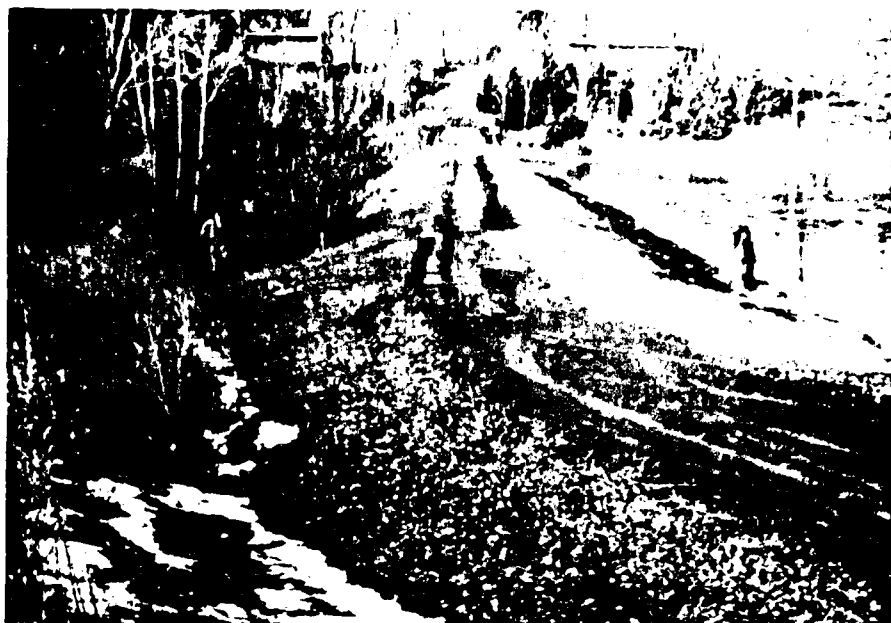
1. Embankment Crest and Right Abutment

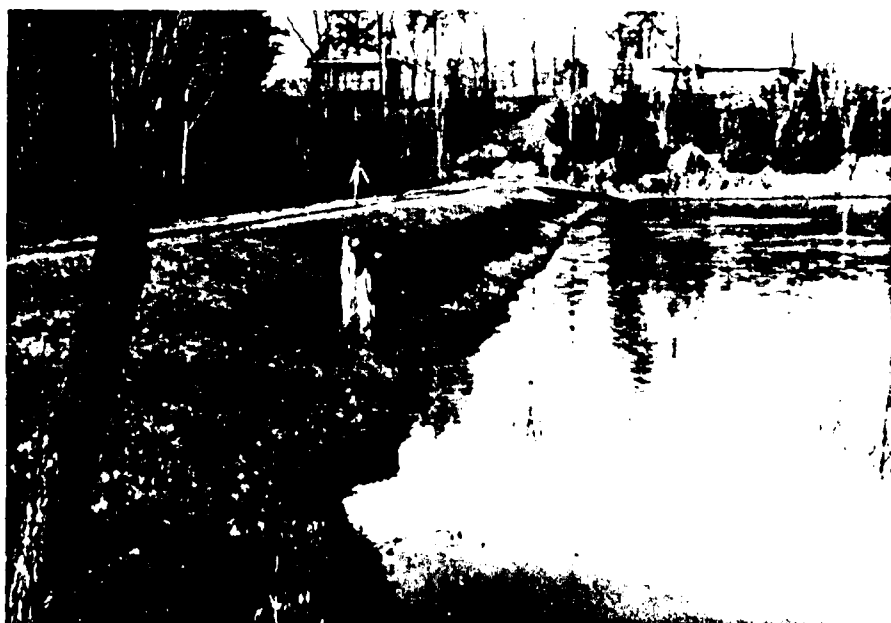
2. Upstream Face and Right Abutment

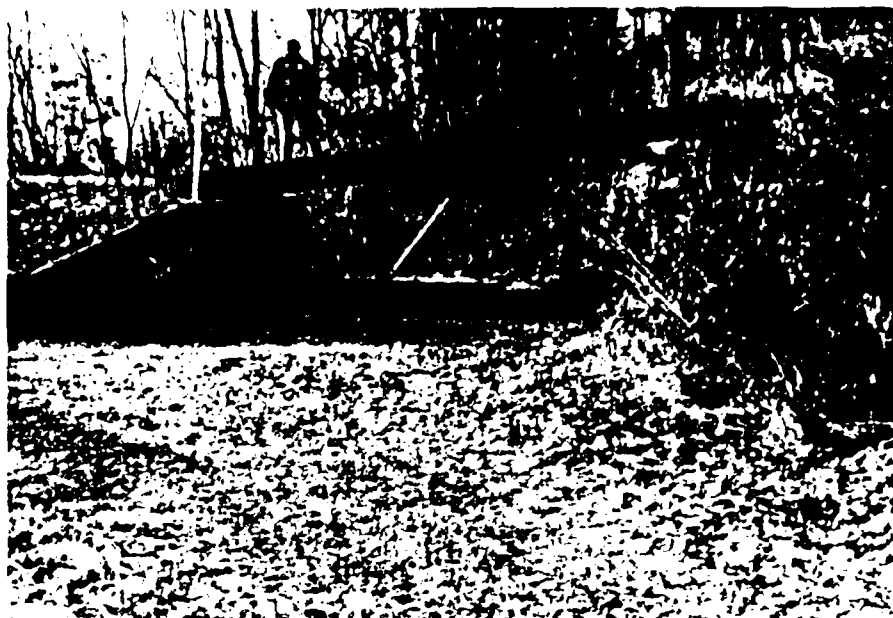
c. Appurtenant Structures. The location of the outlet works and the spillway are shown on the field sketch in Appendix A. The spillway approach channel is the reservoir with approximately the first 20 feet being grass covered. The spillway slab and walls are cracked and in poor condition. The left spillway wall is separated from the upstream wingwall and is tilting. Based on photographs in PennDER files, the right spillway wall was originally constructed to the same height as the left wall. Sometime after April 1964 the right wall was raised about 3 feet by placing concrete block with mortared joints on top of the existing wall. A 4 foot high by 6 foot long triangular section of this concrete block has failed. The remaining concrete block is leaning and separating at the mortared joints. The upstream end of the original concrete wingwall is also seriously cracked and leaning. Concrete in the form of a bulge is visible beneath the bridge and acts as a buttress for the right wall. The spillway walls and slab end approximately 4 feet downstream of the bridge. Material from the right abutment is covering a portion of the right side of the slab to a maximum depth of 2 feet.

5. Approach Channel to Spillway

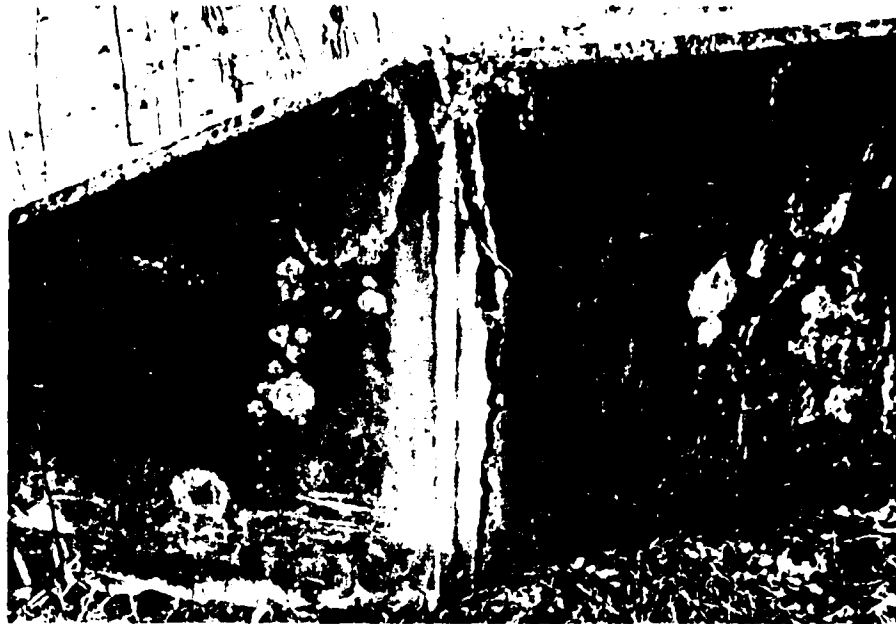
7. Crack in Approach Wall of Left Spillway Wall

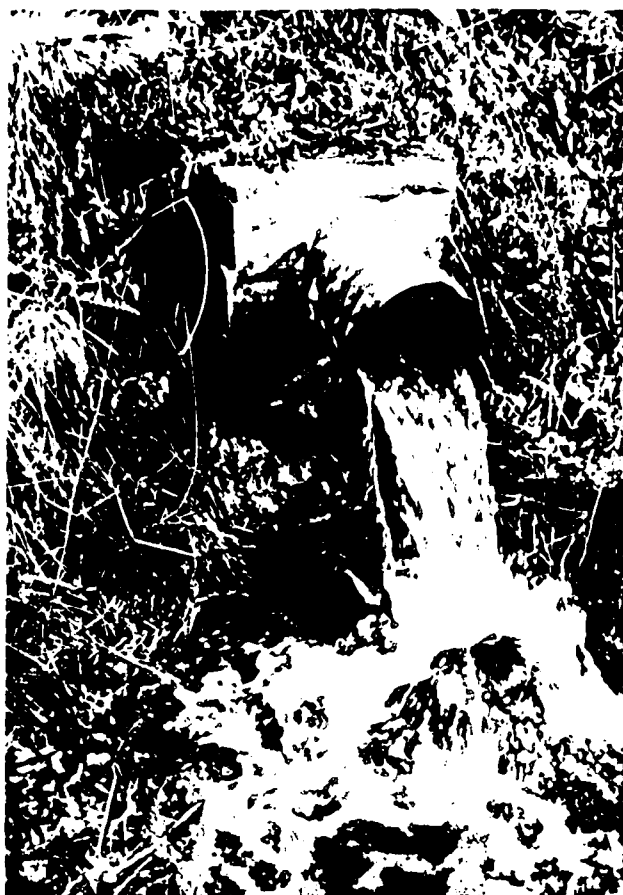
11. Outlet Conduit at  
Downstream Toe of Embankment

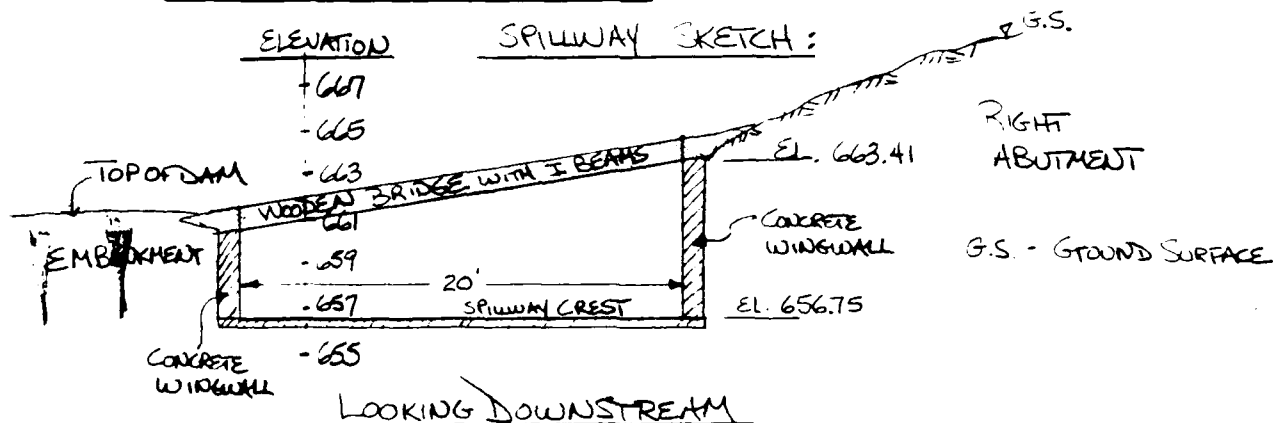
NOTE: ONCE WATER SURFACE ELEVATION REACHES 660.55, STEEL I-BEAMS IN BRIDGE BEGIN TO BLOCK SPILLWAY FLOW AS SHOWN ABOVE. THIS OCCURS FIRST ON LEFT SIDE ON SPILLWAY WHERE BRIDGE SLOPES DOWN ONTO EMBANKMENT.

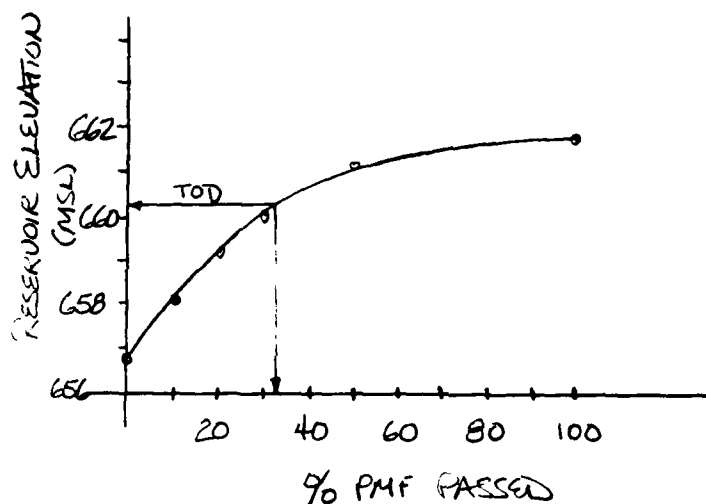
CAN PASS 32% OF THE PMF PRIOR TO OVERTOPPING THE EMANKMENT.

SINCE THE SAF =  $\frac{1}{2}$  THE PMF, THIS FACILITY CAN HANDLE 32% OF THE PMF. SINCE IT IS FELT AT 50% PMF, THE DAM WOULD FAIL DUE TO OVERTOPPING, A BREACH ANALYSIS IS REQUIRED.
